RUPTURE OF A 3000 TON  
SULPHURIC ACID STORAGE TANK

JOHN R. FUTERS

INTERNATIONAL MINERALS & CHEMICAL CORPORATION (CANADA) LTD.  
PORT MAITLAND PLANT, DUNNVILLE, ONTARIO

PAPER PRESENTED AT THE ANNUAL TECHNICAL MEETING OF THE A.I.C.E.  
CENTRAL FLORIDA & PENINSULAR FLORIDA SECTIONS

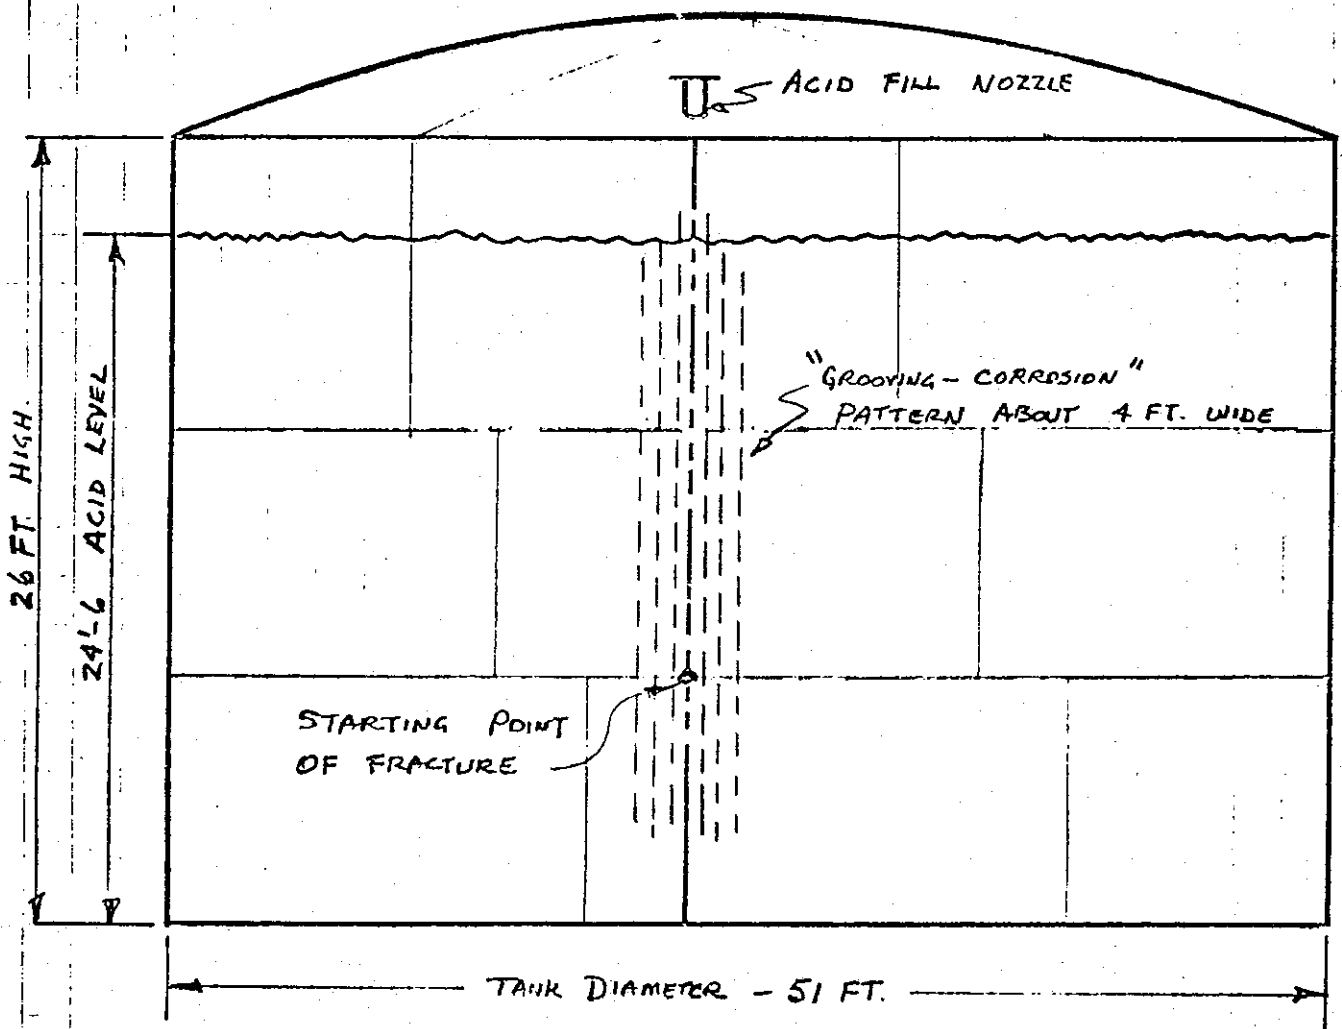
(FIG 2.)

The grooving - corrosion pattern occurred on the tank side wall directly in line with the acid fill nozzle. The pattern started about 3 ft. below the tank roof line and extended to within 1 ft. of the tank floor. The grooves in the plate were straight and vertical with a spacing of about 1/8 inch and were cut into the plate about 1/16 inch deep. The pattern was relatively narrow, and extended about 4 ft. around the tank circumference. This area showed general thinning of the platework as well as the grooved pattern.

The cause of this unusual corrosion pattern was probably a combination of:

- a) Acid flowing down the tank side wall due to location of tank fill nozzle about 1 ft. from the sidewall.
- b) Acid temperature coming from the plant coolers was about 100°F. Corrosion rate would therefore be higher than if acid were at ambient temperatures (see Fig. 1).
- c) Hydrogen bubbles rising along the steel surface on a vertical plate can cause deep grooves to be cut in the surface. This has been demonstrated experimentally.
- d) Longer periods of plant operation into this tank as compared to other tanks.

The tank rupture occurred vertically through the steel platework near the center of this grooved pattern, directly in line with the tank fill nozzle (see Fig. 2). The rupture appears to have started about 8 ft. from the tank floor at a horizontal weld seam which had thinned where the vertical corrosion grooves crossed the weld at right angles. The fracture line was straight from top to bottom of the tank wall. When the fracture line reached the "T" weld joints where tank wall plates were attached to floor plates and roof plates, the welds were sheared off around the entire tank floor and roof circumference. With the sudden release of potential energy from acid stored in the tank, the tank walls unrolled to an almost linear position rather than their previous circular position.

3000 TON SULFURIC STORAGE TANK
