Paper prepared by Allen W. Hearn and David H. Konopnicki
Plant Engineering Department, CF Industries, Inc., Plant City, Florida
Presented at the May 23, 1992 AIChE Clearwater Convention

**SUDDEN CATASTROPHIC FAILURE OF A
RUBBER LINED PHOSPHORIC ACID TANK**

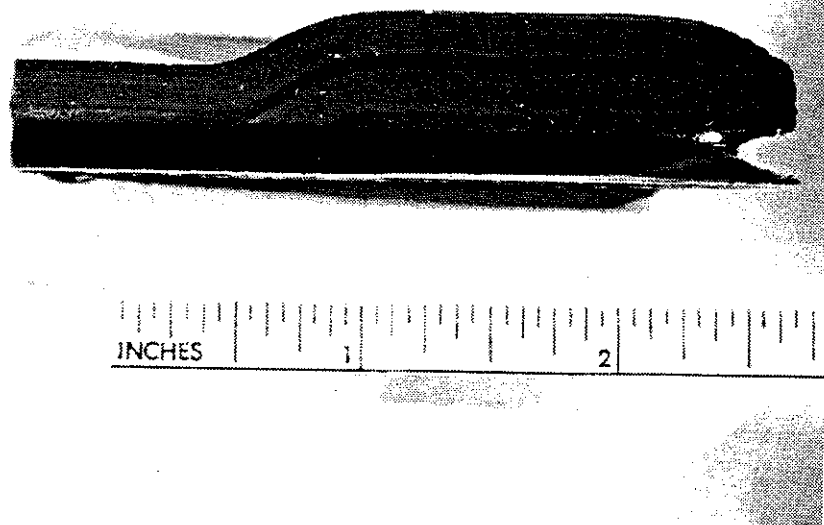
Figure 10. Cross-section through the lapped joint in the rubber liner on the north edge of the rupture.

The darker tie gum bonding the rubber to the steel is readily visible, as is the undercutting of the rubber at the rupture and the thinning of the shell. White deposits are visible at the crevice between the rubber and the corroded steel shell.

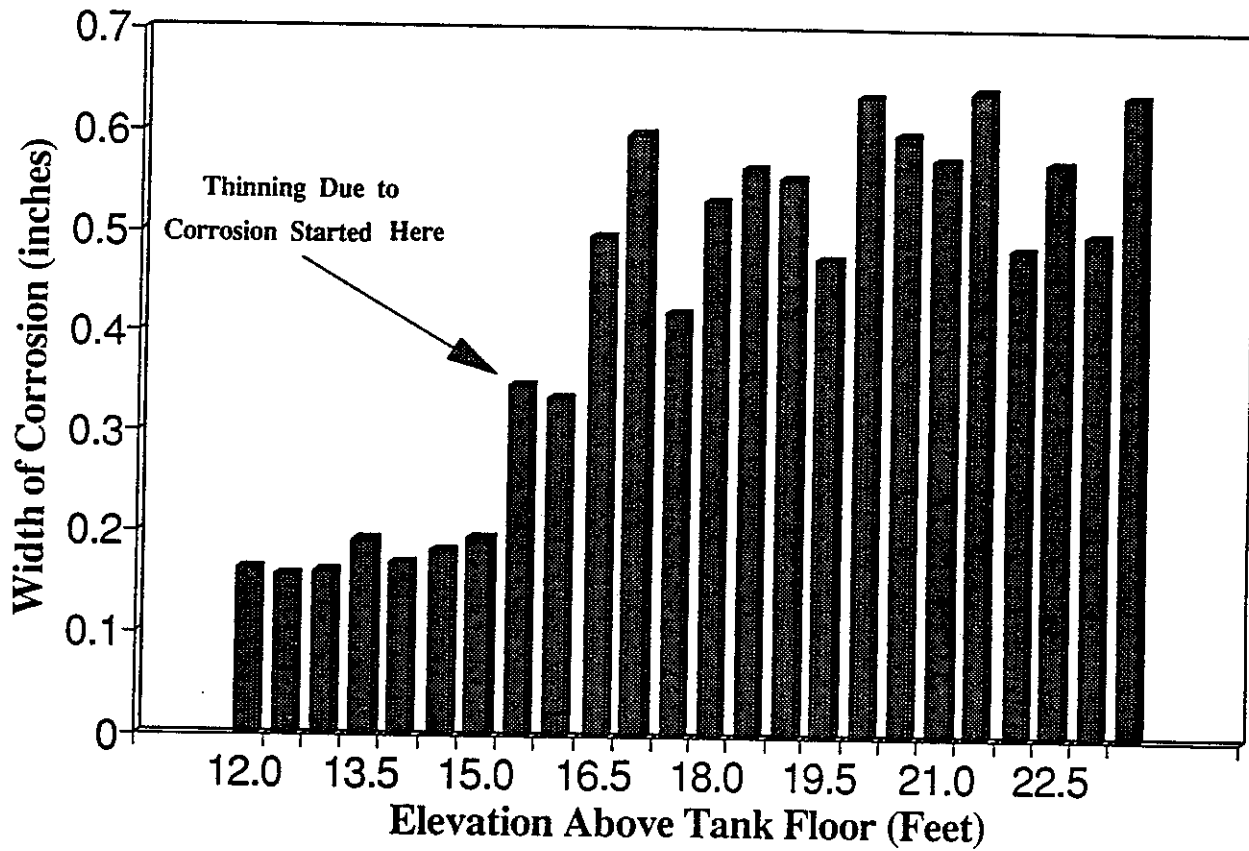
Figure 12. Width of debonding of the rubber liner along the south edge of the rupture as a function of elevation above the tank floor.

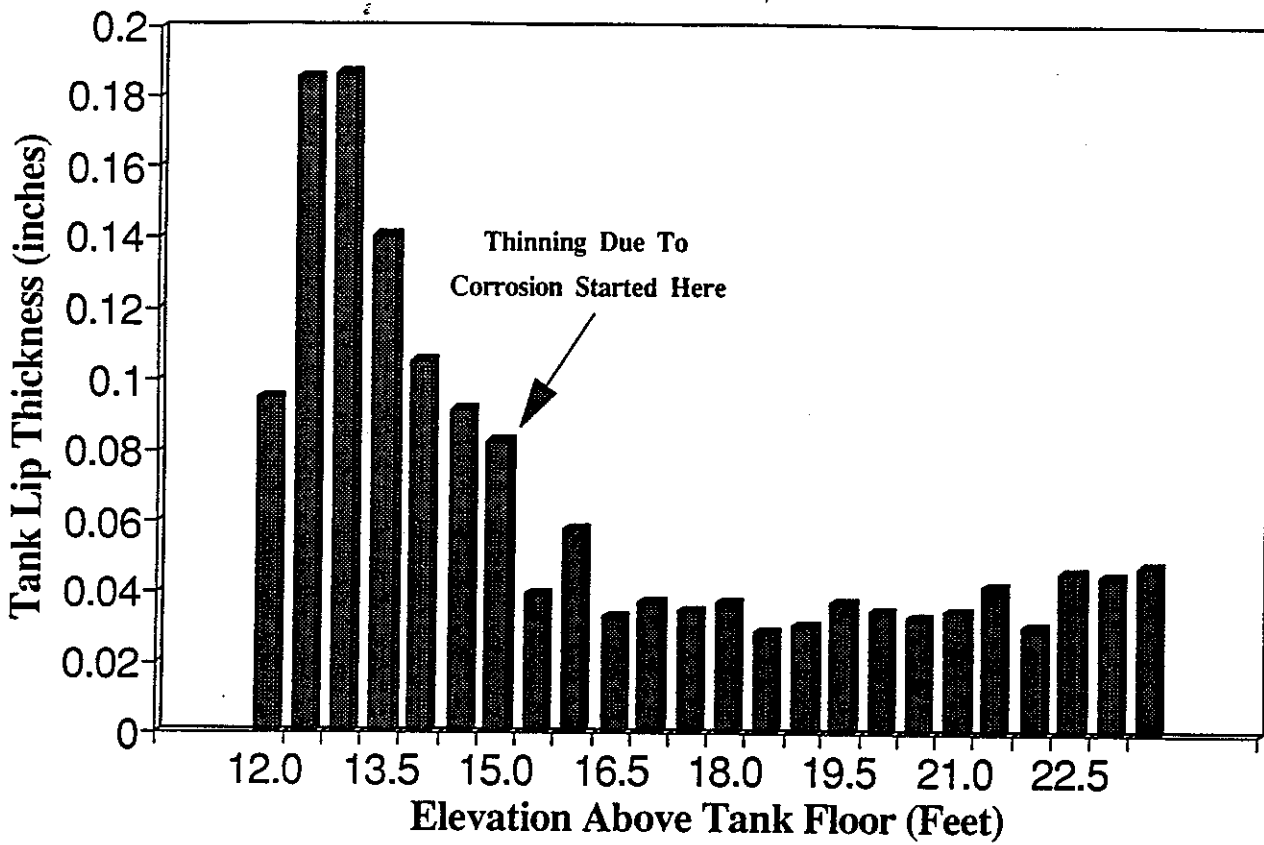
Figure 11. Thickness of the lip along the south edges of the rupture as function of elevation above the tank floor.
