## **Sinkhole Remediation at a Phosphogypsum Stack**

**Nadim F. Fuleihan**  
Ardaman & Associates, Inc.

### **Background**

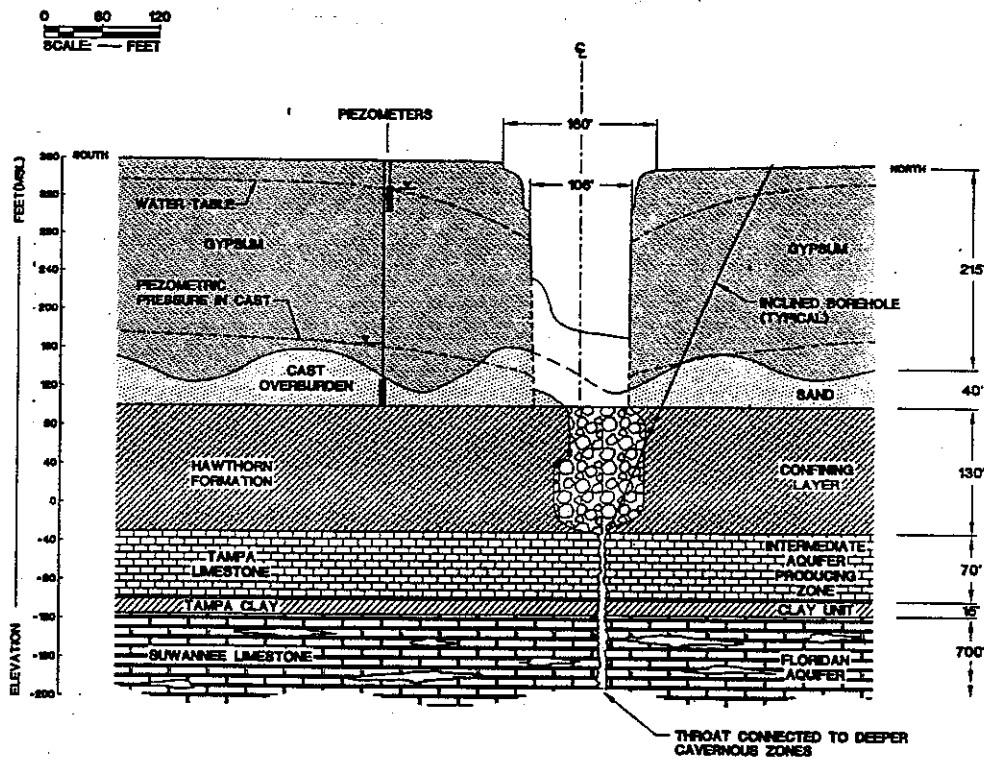
Figure 1. Geologic Cross Section Depicting the Sinkhole

On June 27, 1994, an erosion sinkhole occurred in the 200-foot high original phosphogypsum storage area at the New Wales Plant of IMC-Agrico Company, in Polk County, Florida. The hole measured 160 feet in diameter at the surface. It tapered down to a 110-foot wide shaft which stood essentially vertical from the top to the base of the 200-foot thick sedimentary gypsum deposit (see Figure 1). The open shaft was connected to an erosion cavity which was infilled with collapsed gypsum blocks and which extended into the natural soil and rock formations beneath the phosphogypsum stack to a depth of 400 feet.

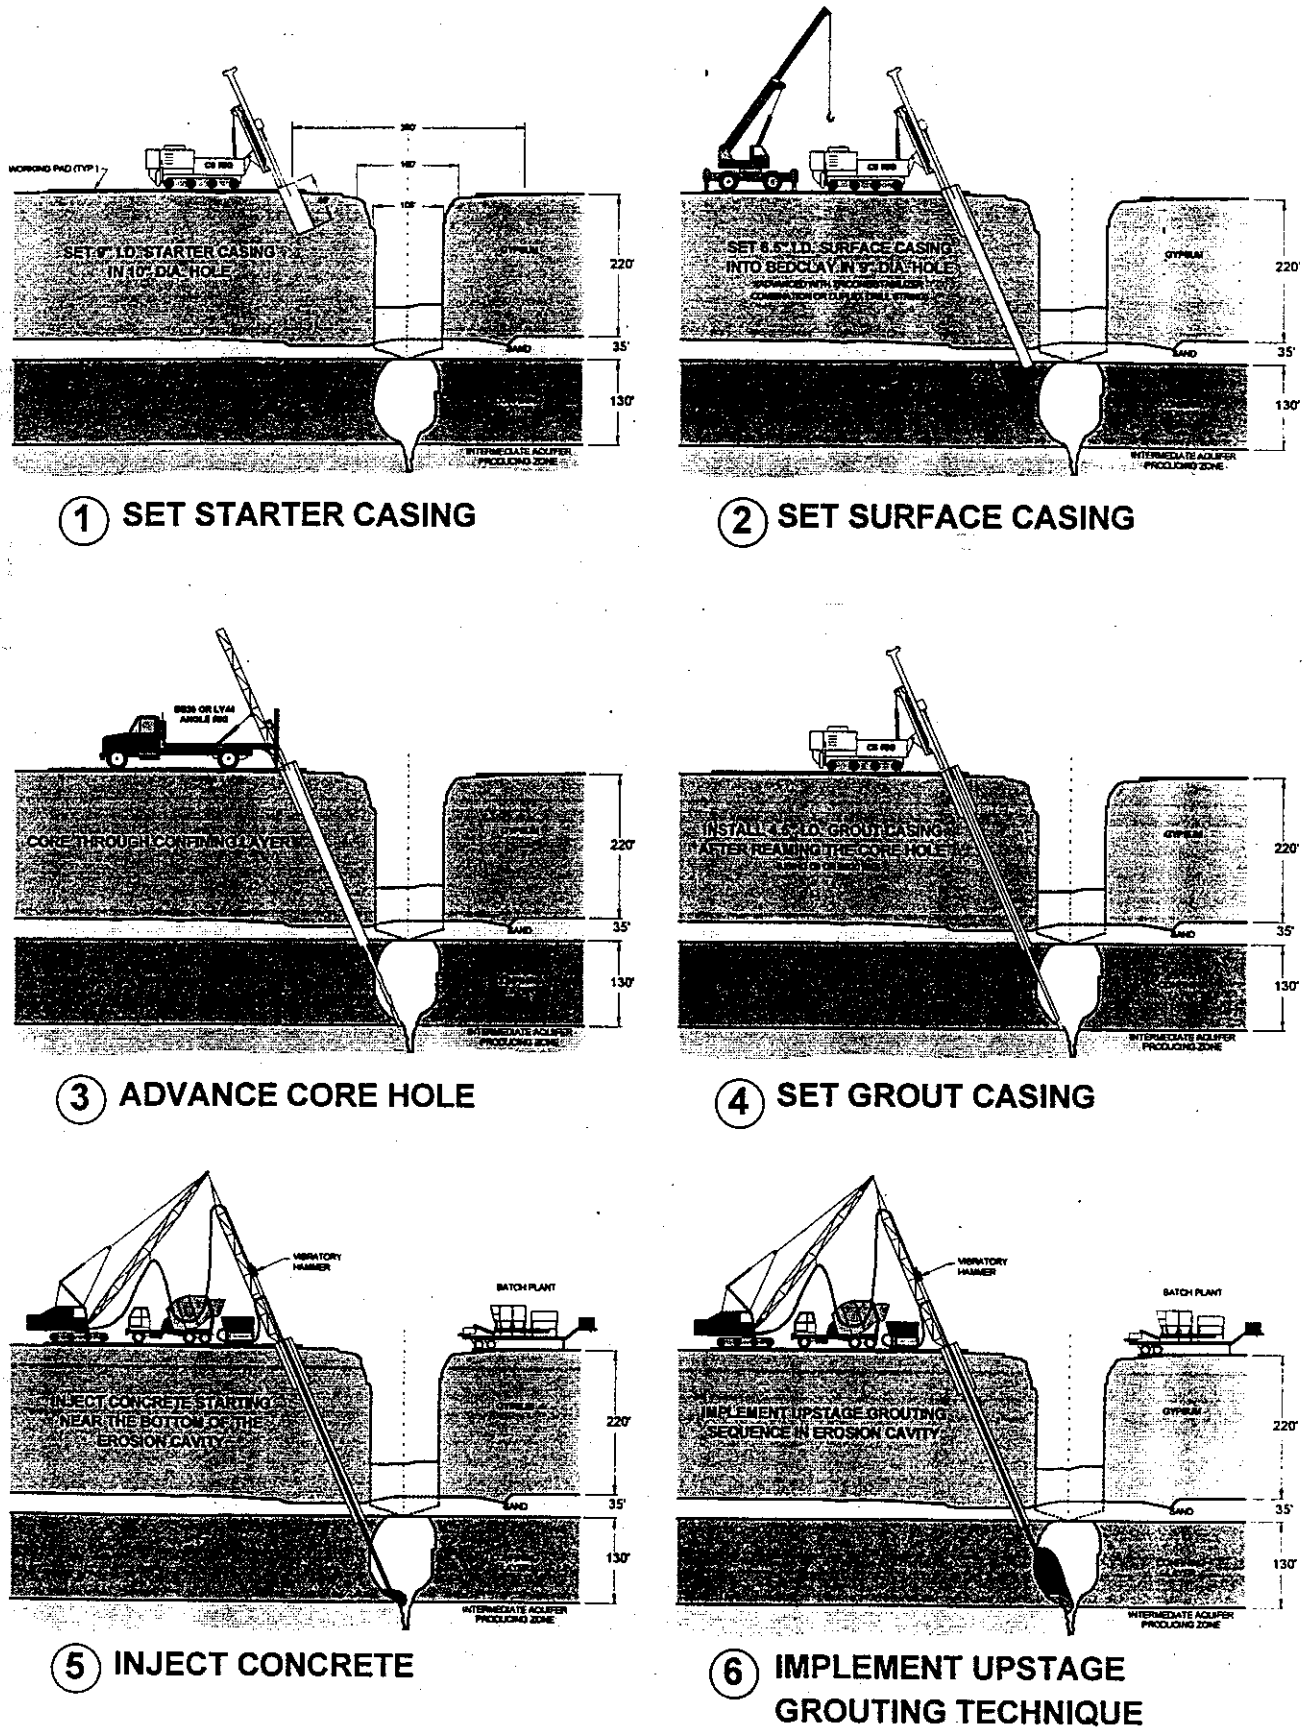
Figure 3. Drilling/Grouting Methodology

A multi-step drilling methodology needed to be implemented while advancing each grout casing to inclined lengths of up to 450 feet (see Figure 3). Three telescoping casing sizes needed to be used in advancing each hole. Because of the corrosive nature of the pore water (pH on the order of 1.5 to 2.0), the 300-foot long steel surface casings (also used as inclined guides to the grout casings) had a very limited life span. The operations had to be planned, therefore, to complete drilling and grouting as expeditiously as possible after installation of a surface casing at any given location. Moreover, several types of rigs had to be used. They included a Casagrande C-8 rig geared for "blow and go" type production drilling; and a top drive BB20 wire line rig, developed by Longyear (and mobilized for the first time ever on this project), used to obtain large diameter core samples in order to: (i) define the limits of the erosion cavity; (ii) verify the grout spread from prior injections; and (iii) prepare a pilot hole for setting the grout pipe. The New Wales Plant machine shop had to work daily (and occasionally nightly) making adapters to accommodate incompatible English and Metric tools used by the different type of specialty drill rigs.

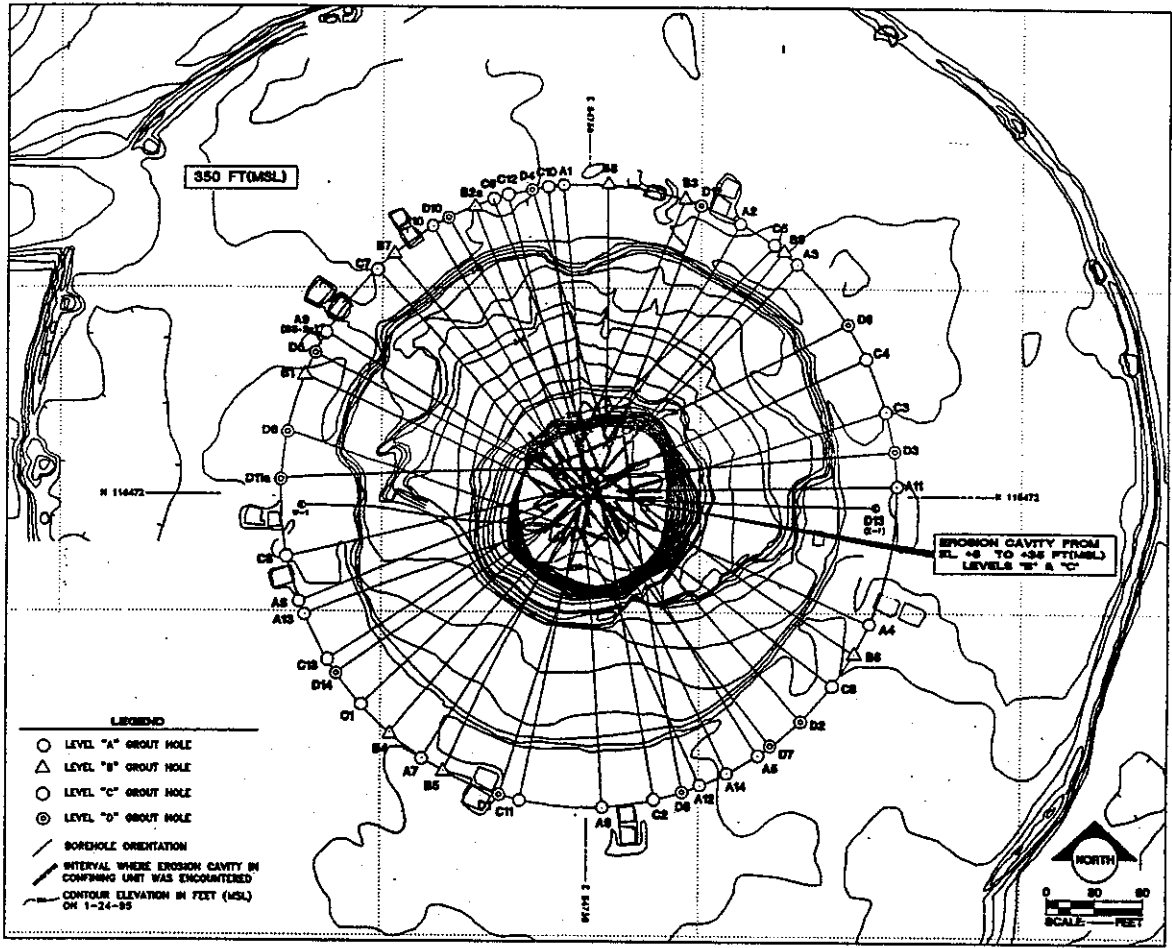
Figure 4. Grout Hole Location Plan

Round-the-clock operations were carefully planned to expedite the repair work and to allow for efficient coordination of simultaneous drilling and grouting activities in the very limited work area available around the scarp, while, at the same time, precluding grout from flowing from an injection casing towards another hole that was still being advanced or that had not been grouted yet. This task was particularly challenging because of the close proximity of a large number of inclined grout casings (Figure 4).

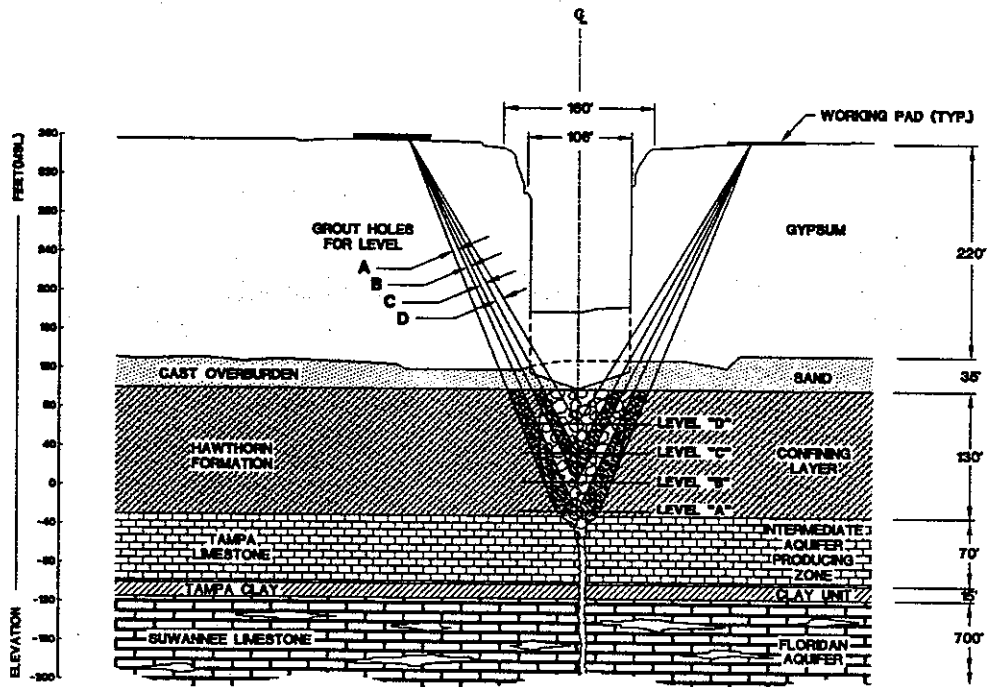
Figure 5. Cross Section Illustrating Target Grout Levels

Installation of the casings for grout injection purposes was phased, progressing from the perimeter towards the center of the erosion cavity and from deeper target levels to shallower levels in the confining unit (Figure 5). The objective was to seal the throat or bottom of the cavity in the confining unit prior to grouting the bulk of the erosion cavity in order to minimize grout losses into the underlying cavernous network. Holes targeting relatively shallow levels in the erosion cavity were generally extended to greater depths in order to sample previously injected grout, and in order to provide some redundancy, i.e., an opportunity for injecting additional primary grout (i.e., pea gravel concrete) or secondary grout (i.e., liquid grout), if feasible, even where adequate grout coverage had been previously achieved.

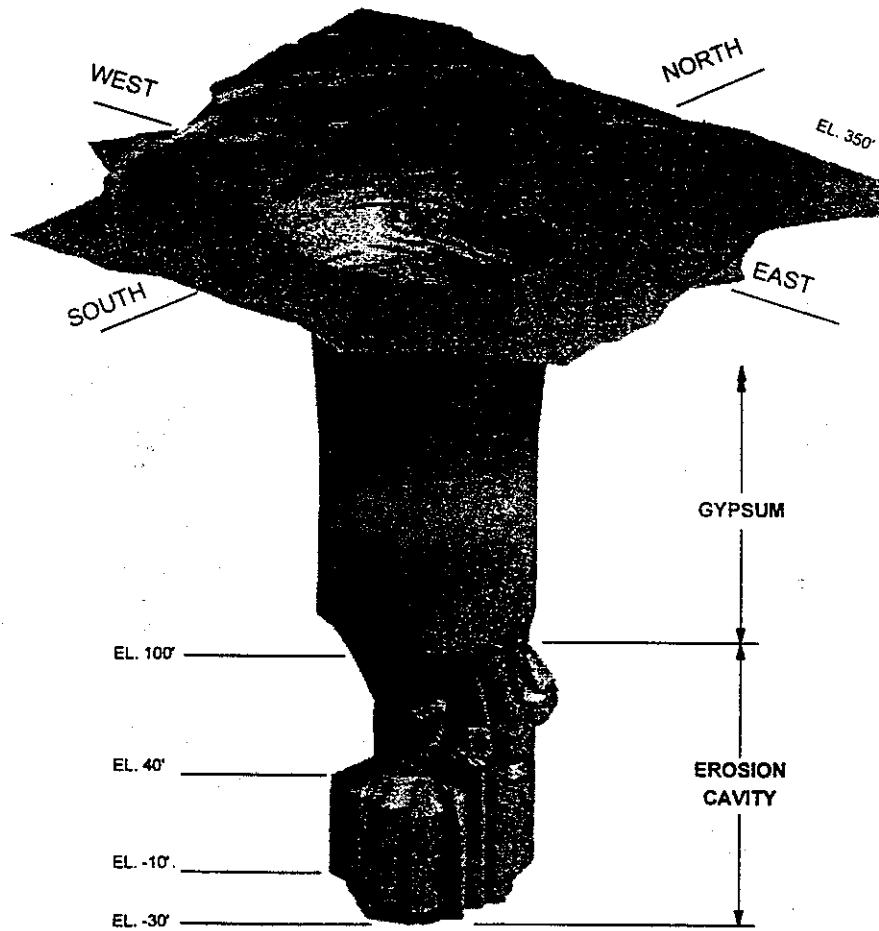
**Figure 6. 3-D View of Erosion Cavity**

Based on a total of 55 coreholes that penetrated the erosion cavity in the confining unit, the cavity occupied a total volume on the order of 19,200 cubic yards (cyd), as illustrated in Figure 6. Based on the cores recovered, the cavity was primarily infilled with cemented gypsum "blocks" or "boulders" (generally ranging in thickness from about 2 to 8 feet) that had previously collapsed from the gypsum stack. The concrete was injected into the erosion cavity at high pressure not only to fill the voids but also to cause the grout to flow via hydraulic fracturing. In fact, the grout was found to be intimately bonded to the gypsum blocks within the erosion cavity, thus forming a "new material" designated "gypcrete" (see Figure 7). A grout spread distance in excess of 15 feet (and up to 25 feet) was documented from core samples retrieved from the erosion cavity.

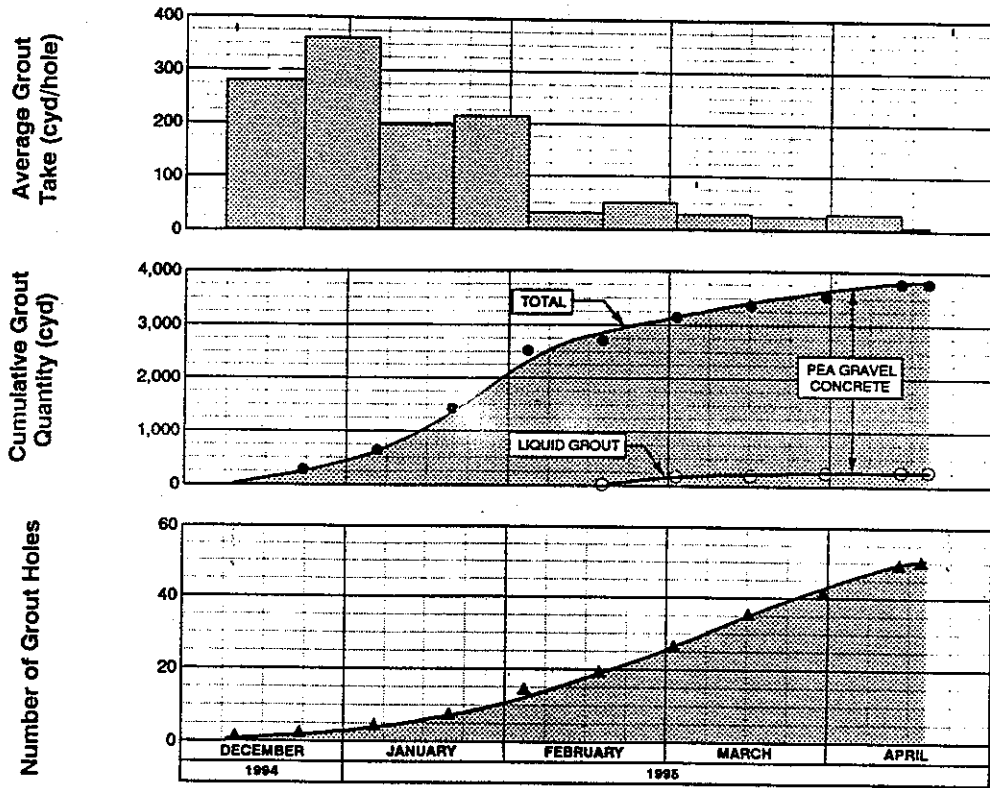
Figure 8. Chronologic Overview of Grouting Activities

As illustrated in Figure 8, the grout take per hole exhibited a marked decrease from an average of 200 to 350 cyd/hole (between December 1994 and February 1995), to less than 50 cyd/hole (beginning in February 1995) when the throat of the sinkhole was plugged. From then on, the grout take remained relatively low, i.e., generally on the order of 25 cyd/hole or less (from February 1995 through April 1995), indicating that the erosion cavity had become tightly filled and that the grout was primarily spreading during these latter stages via the mechanism of "hydraulic fracturing". Even though the grout take remained low, a conscious decision was

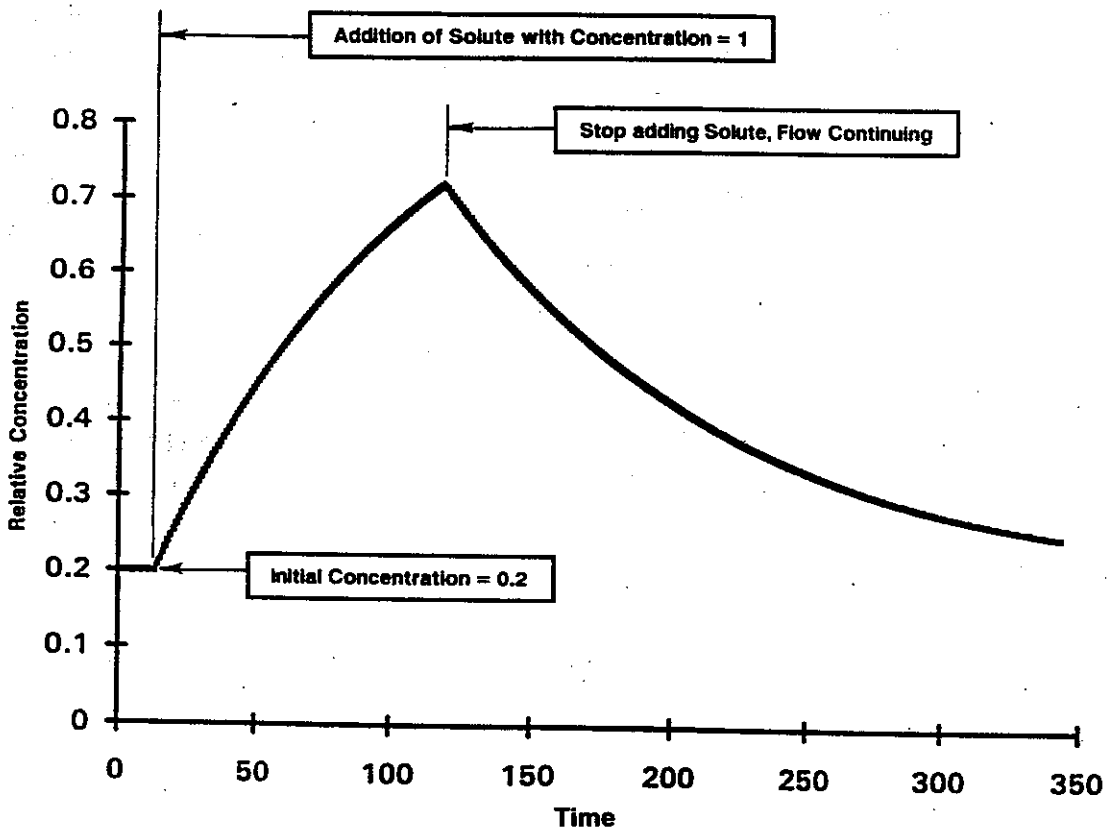
Figure 11. Relative Concentration in a Continuous Stirred Tank Reactor

Even though the sinkhole was successfully remediated, and the hydraulic connection between the phosphogypsum stack and the Floridan Aquifer was plugged, it may take some time for the water quality in the production wells to return all the way to background concentrations. As noted above, most contaminant levels in the production wells have decreased systematically since March 1995. Nevertheless, it is anticipated that several years may be required to completely remove all contaminants from the aquifer because purging an aquifer from contaminants generally occurs at a much slower rate than that characterizing the breakthrough front, as schematically illustrated, for example, by the theoretical concentration in a continuous stirred tank reactor presented in Figure 11. Moreover, purging of the aquifer from impacts is

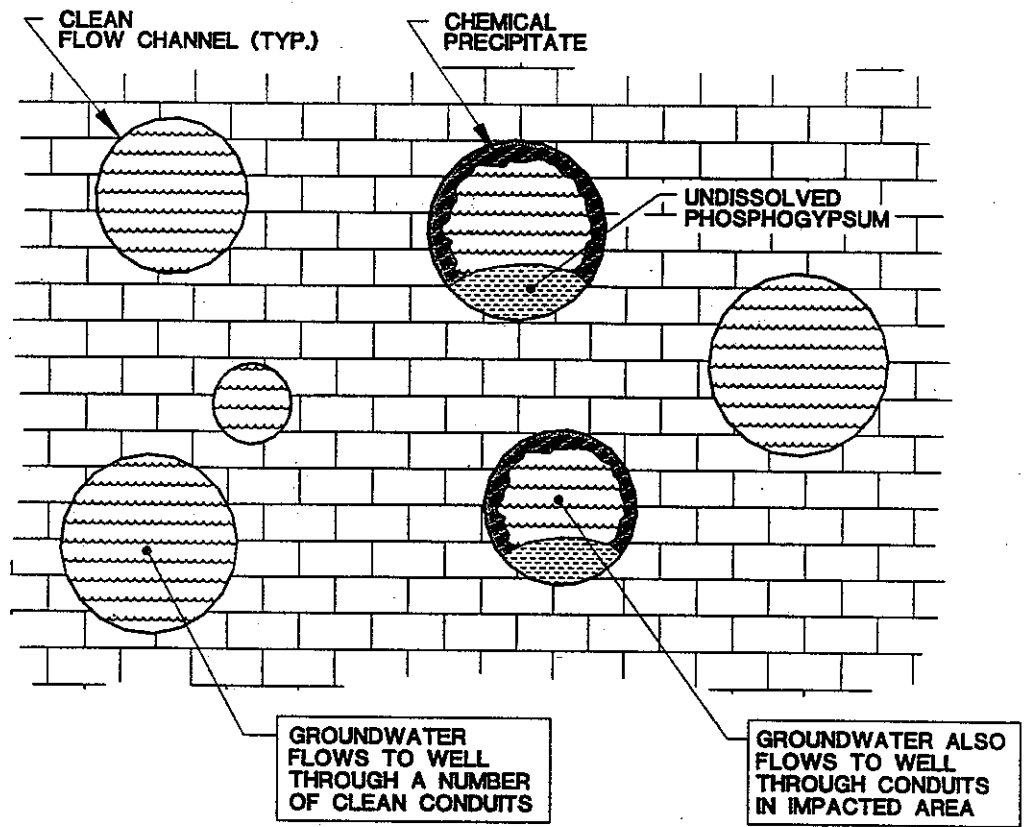
Figure 12. Flow Pattern Illustrating the Redissolution of Precipitates

delayed by the redissolution of some of the reacted precipitates in the impacted area, as well as the dissolution of as much as 26,000 cyd of gypsum crystals that have fallen from the stack into the aquifer system, as schematically illustrated by the flow pattern in Figure 12. Laboratory test results indicate that whereas one mixing cycle is sufficient to contaminate a limestone sample, more than 8 rinsing cycles are in fact required to clean it. Note that as much as 5 years may be required to dissolve all the gypsum that has fallen into the aquifer assuming that dissolution occurs at a rate controlled by the solubility of gypsum in fresh water.
