RUPTURE OF A 3000 TON  
SULPHURIC ACID STORAGE TANK

JOHN R. FUTERS

INTERNATIONAL MINERALS & CHEMICAL CORPORATION (CANADA) LTD.  
PORT MAITLAND PLANT, DUNNVILLE, ONTARIO

PAPER PRESENTED AT THE ANNUAL TECHNICAL MEETING OF THE A.I.C.E.  
CENTRAL FLORIDA & PENINSULAR FLORIDA SECTIONS

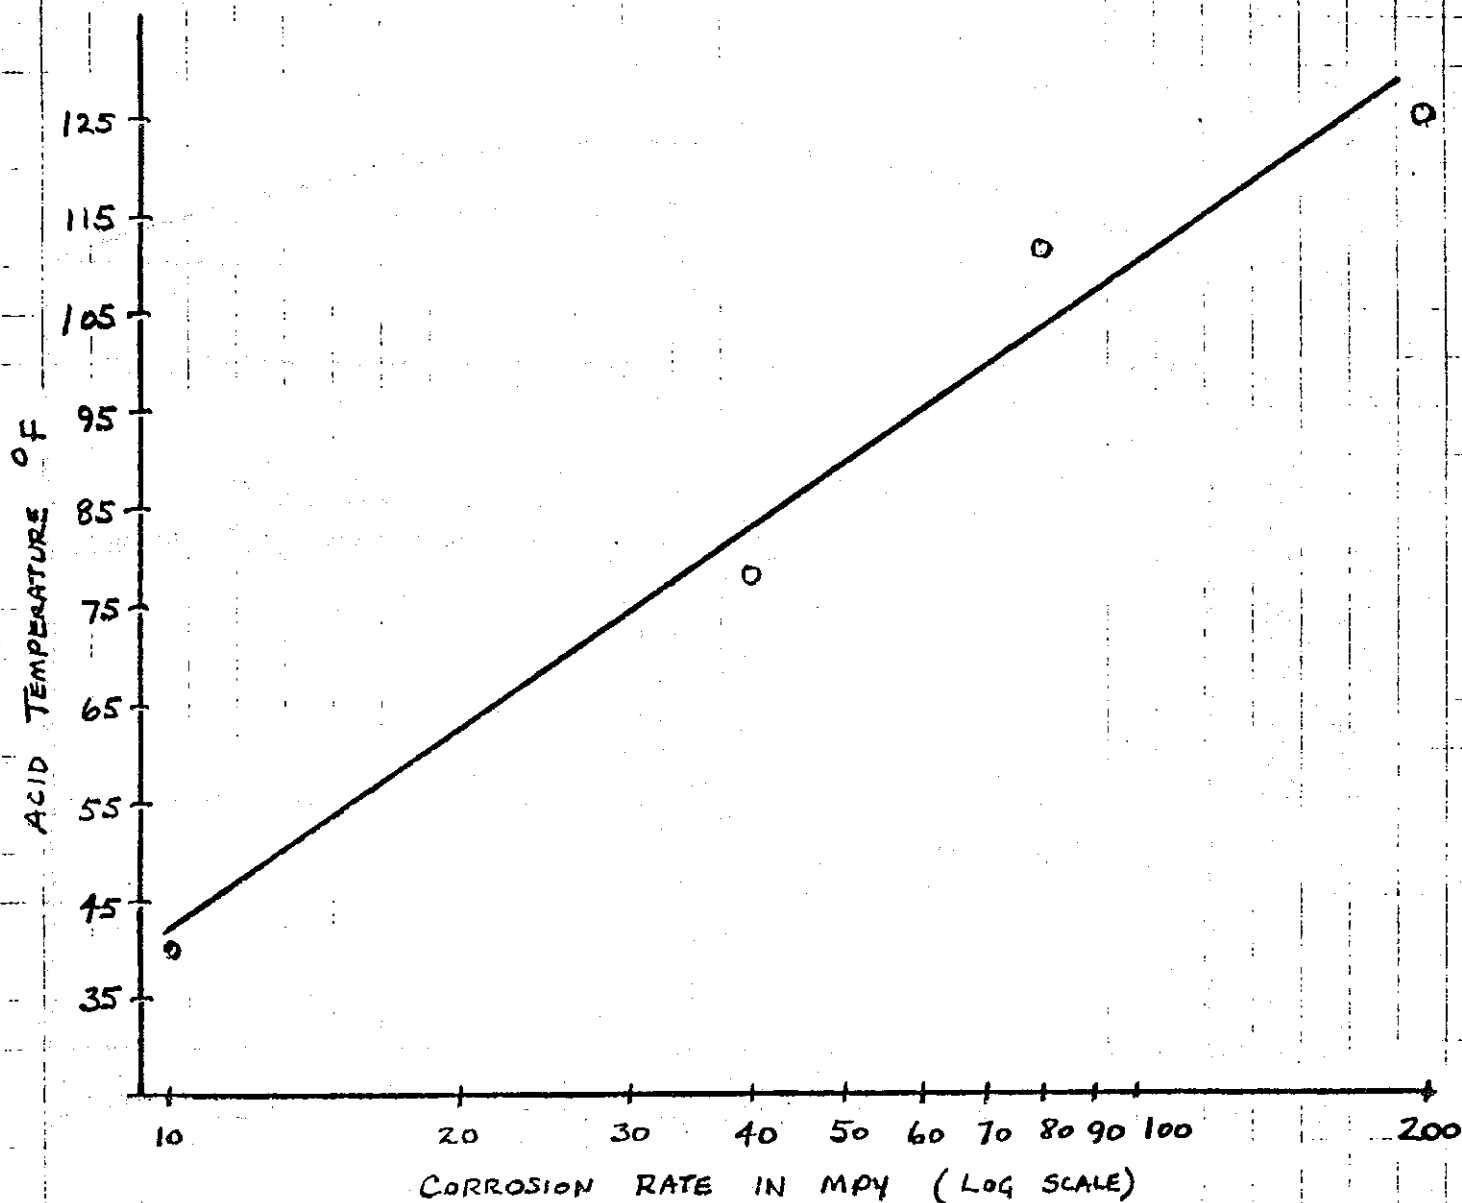
(FIG. 1)

- a) Acid flowing down the tank side wall due to location of tank fill nozzle about 1 ft. from the sidewall.
- b) Acid temperature coming from the plant coolers was about 100°F. Corrosion rate would therefore be higher than if acid were at ambient temperatures (see Fig. 1).
- c) Hydrogen bubbles rising along the steel surface on a vertical plate can cause deep grooves to be cut in the surface. This has been demonstrated experimentally.
- d) Longer periods of plant operation into this tank as compared to other tanks.

TYPICAL - EFFECT OF ACID TEMPERATURE ON THE CORROSION RATE OF CARBON STEEL - 93% SULFURIC
