## **Sinkhole Remediation at a Phosphogypsum Stack**

**Nadim F. Fuleihan**  
Ardaman & Associates, Inc.

### **Background**

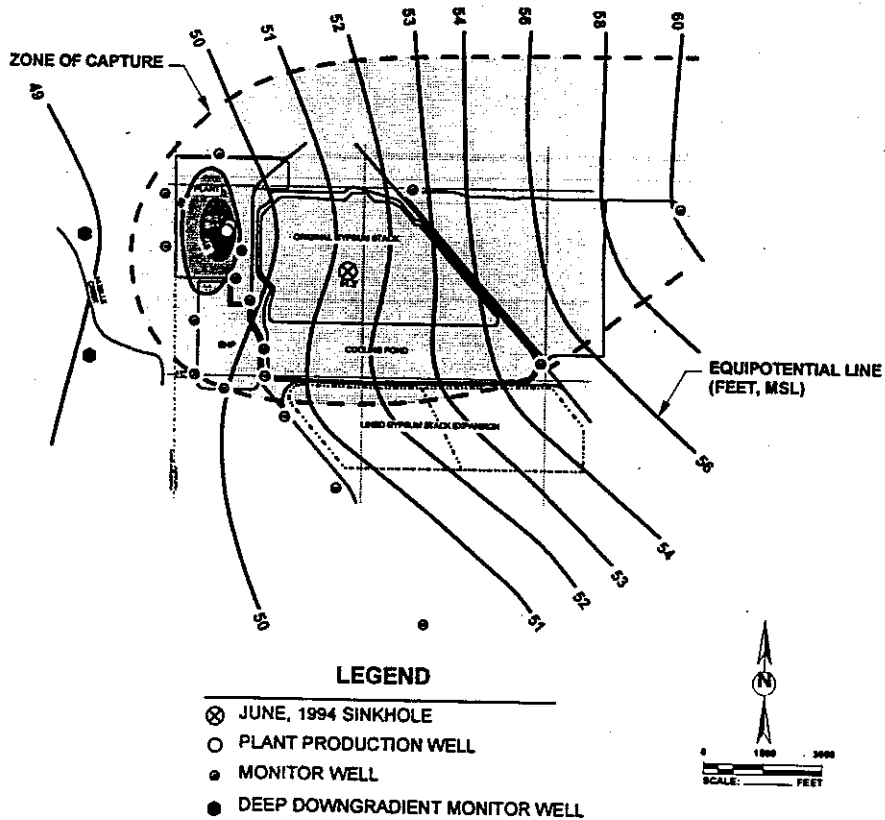
Figure 2. Zone of Capture of Production Wells (as Documented on June 28, 1994 in Floridan Aquifer Monitor Wells)

The sinkhole caused ponded water and seepage water from the stack to flow into an underlying artesian aquifer, the Floridan Aquifer, which is the major water supply source in the State of Florida. The Owner & Engineer responded rapidly to alleviate environmental concerns and determined that any groundwater impacts could be effectively contained on site within the zone of influence of the plant production wells. The corresponding zone of capture (Figure 2) was expediently documented, and was rechecked on several occasions (by actual measurements of water level gradients in over 20 monitor wells), in order to provide reasonable assurance that the contaminant plume would continue to be effectively contained on property. The Owner & Engineer were able to confirm that as long as the plant wells (designated SF-1 and NF-1) were pumped at a combined production rate of 5000 to 6000 gallons per minute to meet the plant's normal operating needs, contaminated groundwater would be contained and captured on site. In fact, the production wells, acting as recovery wells, prevented any contaminants from migrating off property. Water quality data in two deep downgradient Floridan Aquifer monitor

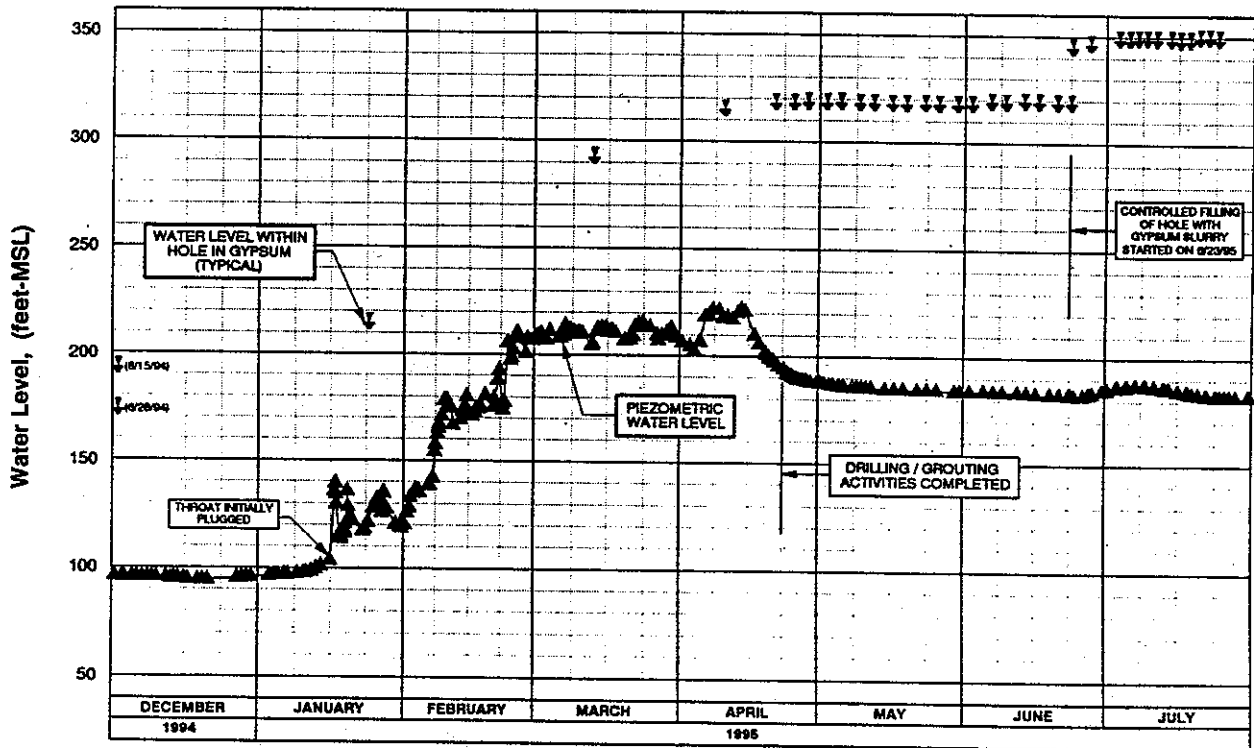
Figure 9. Piezometric Water Level in Upper Zone of Confining Unit Adjacent to the Sinkhole

Extensive monitoring of the water table and piezometric levels in the confining unit was undertaken in order to determine the progress and effectiveness of the remedial work aimed at plugging the erosion cavity. Water levels in piezometers tapping the cast overburden sands (beneath the sedimented gypsum) and underlying confining unit, in the vicinity of the sinkhole, have exhibited a significant rise (on the order of 90 feet) and have sustained high levels since March 1995, confirming that the throat of the erosion cavity has been successfully plugged (see Figure 9). In fact, recently measured piezometric water levels in the vicinity of the sinkhole are consistent with what one would expect in areas of the phosphogypsum stack that have not been affected by the geologic anomaly. Moreover, the water level in the hole within the stack rose by more than 140 feet, to within a depth of 20 feet from the sedimented gypsum surface, and has been very stable since the completion of the sinkhole remediation efforts, indicating that downward leakage has essentially ceased. The water table which had been depressed has also

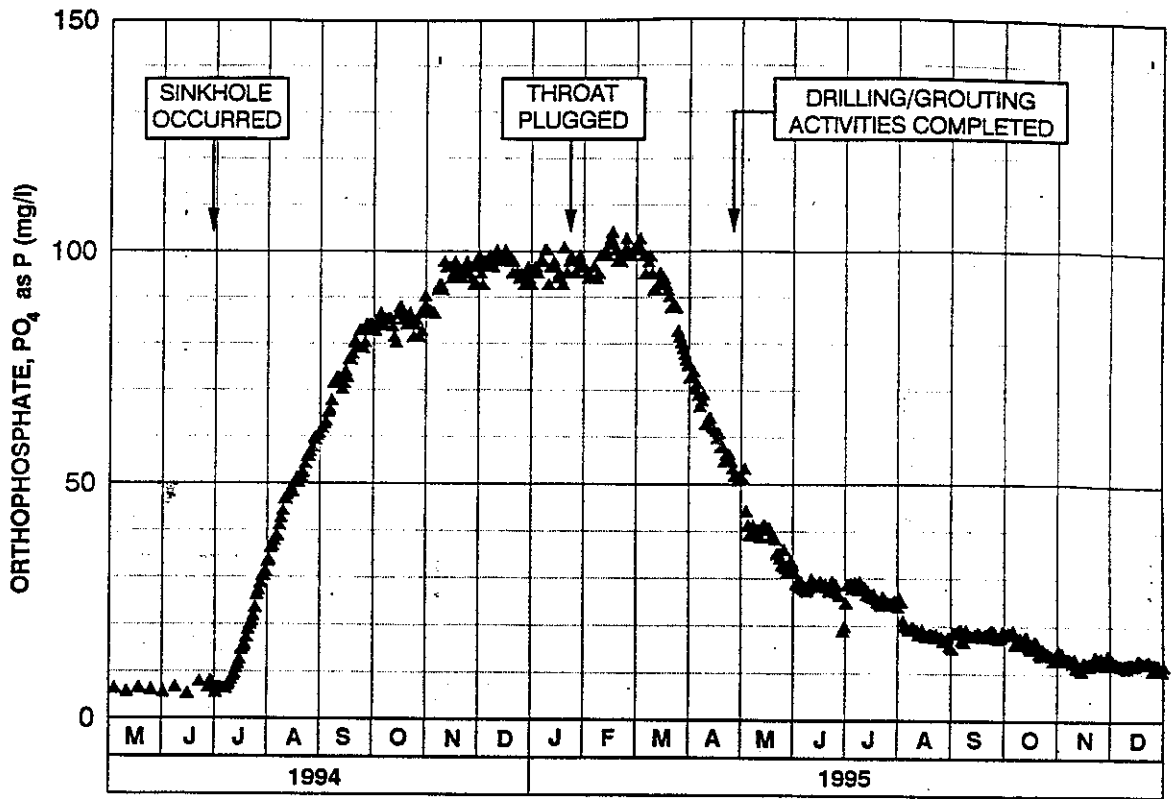
Figure 10. Water Quality In Production Well SF-1

Shortly after occurrence of the sinkhole in late June 1994, chemical concentrations in the plant production wells increased, reaching a "peak" plateau in December 1994. In spite of the impacts attributed to the sinkhole, the water quality in the plant production wells has remained in compliance with primary drinking water standards at all times. Moreover, contaminant indicators in the plant production wells have confirmed the successful plugging of the erosion cavity. Beginning in mid-March 1995, orthophosphate concentrations began reflecting a systematic long-term downward trend (Figure 10). Other indicator parameters (i.e., sodium, sulfate and total dissolved solids) also began to exhibit a similar downward trend due to curtailment of the seepage attributed to the sinkhole.
